IP Office Technical Tip

Tip Number: 258

Release Date: 12 December 2013

Unified Communications Module reverts to “write protect” mode causing Preferred Edition Voicemail to shut down

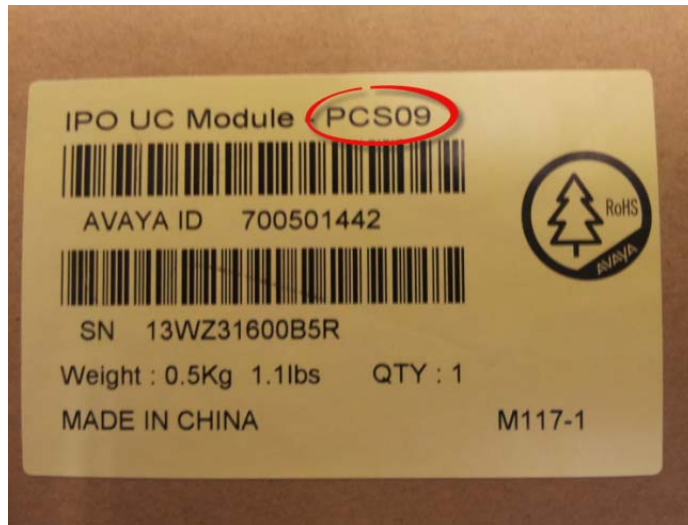
Figure 1

Also, modules exhibiting this issue will have PCS level 9 and PCS level 4 for the on-board SSD. The PCS level for the UCM can be located on either the UCM shipping box (see figure 1) or on the UCM itself (see figure 2). The PCS for the on-board SSD is located on the top right of the blue sticker that is attached to the drive (see figure 3).

The corrective action is to install a Critical Patch (CP) on the UCM through the UCM WebControl Application. The Critical Patch can be found at <http://support.avaya.com>.
