IP Office Technical Bulletin

Bulletin No: 183
Release Date: 14 September 2015
Region: Global

General Availability (GA) - IP Office Release 9.1 Service Pack 4

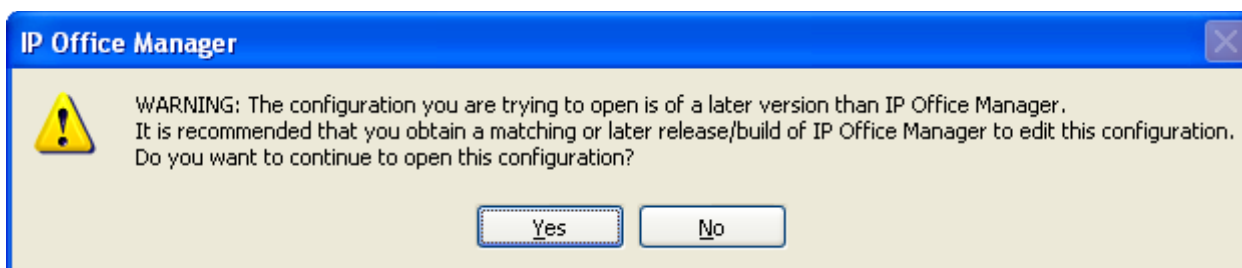
Earlier releases of IP Office 9.1 Manager are not compatible with systems running this release. Before upgrading an IP Office system to the 9.1.4.0.137 release, the Administration suite must also be upgraded. The following message will be displayed if attempting to access a system running the 9.1.4.0.137 release with an earlier version of Manager:

The IP Office Administration installer will detect previous installed versions and upgrade automatically. If a version earlier than 9.0 is installed, this must first be uninstalled before installing 9.1.4.0.137. It is not necessary to restart the PC after upgrading unless instructed to do so.
