IP Office Technical Tip

Tip Number: 258

Release Date: 12 December 2013

Unified Communications Module reverts to “write protect” mode causing Preferred Edition Voicemail to shut down

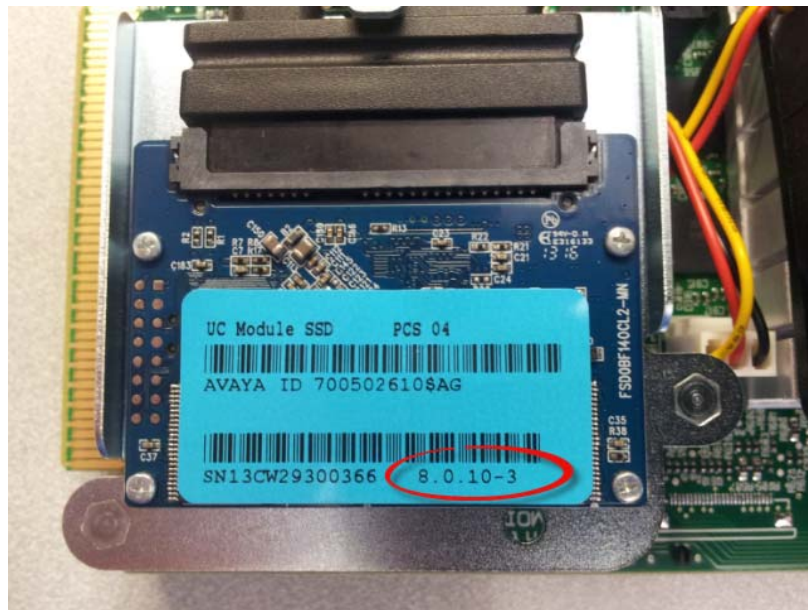
Figure 4

The level of software that is pre-loaded on the UCM is identified by the light blue sticker that is placed on top of the SSD drive. In the example below the UCM is running release 8.0.10-3 of software (figure 4):

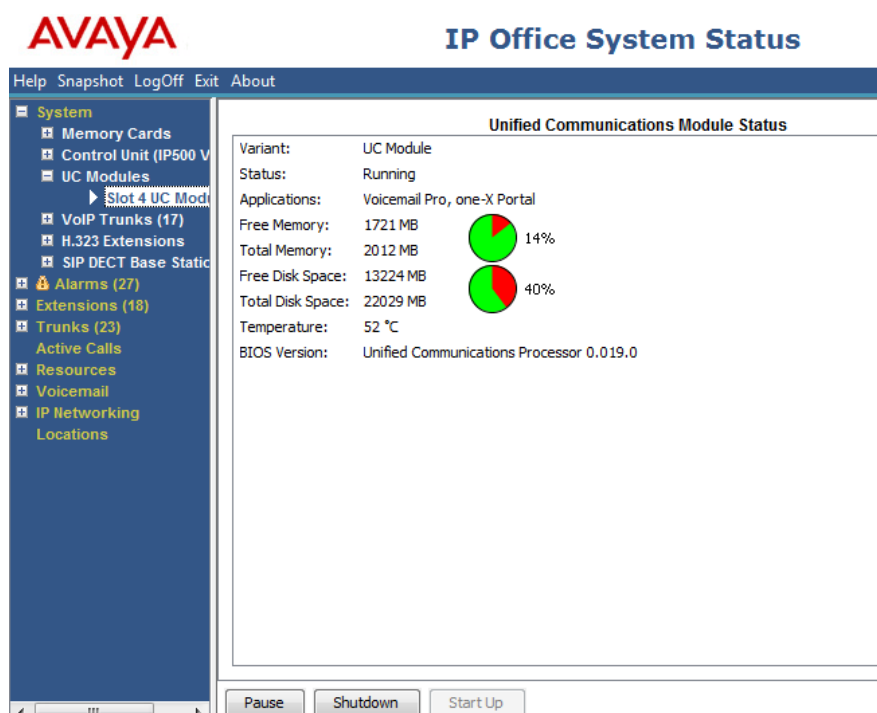
Figure 6

Once the UCM has completed the start-up process the diagnostic information will be displayed in the SSA (see figure 6):

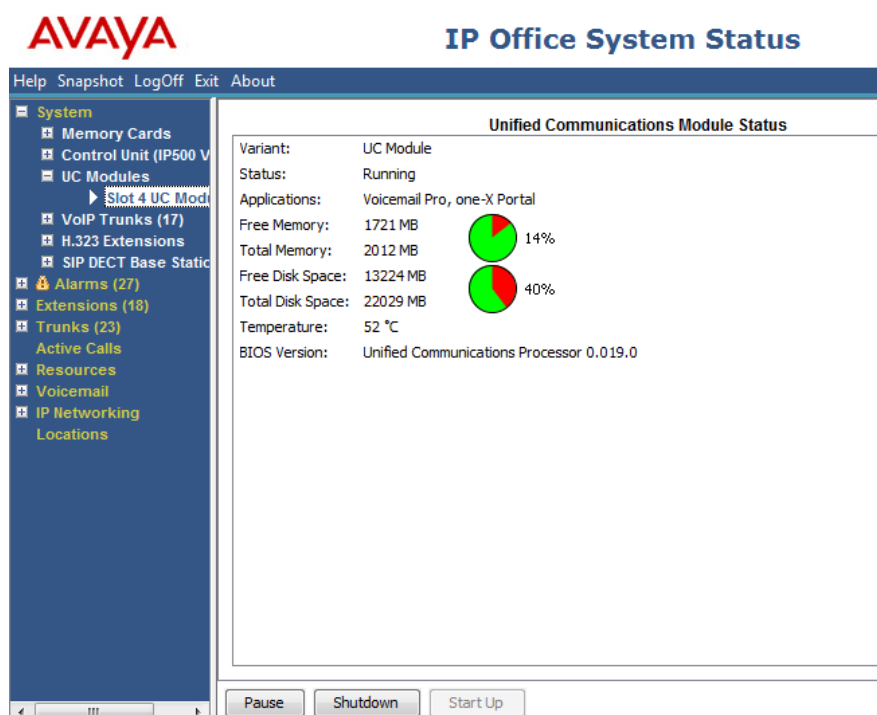
Figure 8

Once the UCM has completed the start-up process the diagnostic information will be displayed in the System Status Application (SSA) (see figure 8).
