IP Office Technical Bulletin

General Availability (GA) of the Avaya IP Office 3.0DT Q1 2008 Maintenance Release

Avaya is pleased to announce the availability of the IP Office 3.0DT 3.0(580) Maintenance Release. This is a scheduled Maintenance Release addressing a number of field issues found in the IP Office 3.0DT GA releases.

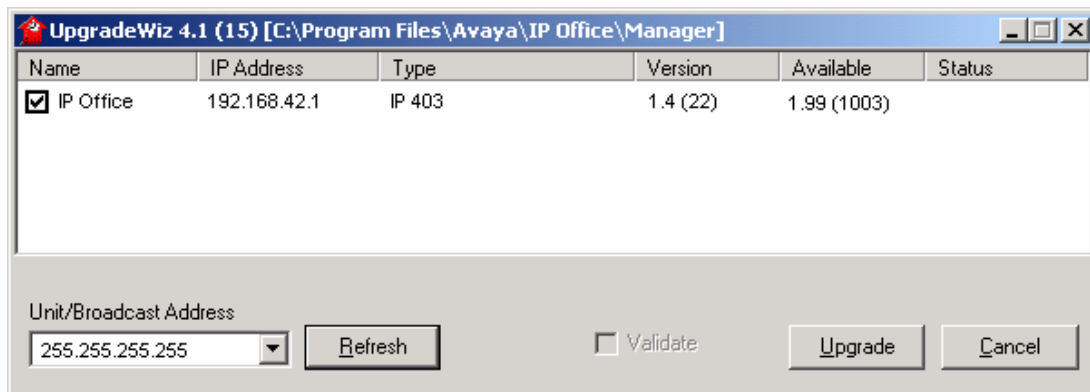
3. Open the Manager and ensure that you have received and made a backup copy of the latest IP Office configuration. If for any reason the upgrade fails, the current configuration may be erased, so a backup copy is essential.
4. In Manager select File | Advanced | Upgrade. This will start the UpgradeWiz application.
5. After a few seconds the upgrade wizard should show the Control and Expansion units found.
6. If no units are found using the broadcast address 255.255.255.255, this implies that the Manager PC is not on the same LAN as the IP Office. You should not continue in this case until you identify a Manager PC on the same LAN as the IP Office.
7. A window similar to the one below is displayed. The list shows the current software levels of the units and the level of the appropriate bin file that is available in the Manager/Binary working directories.

8. The current version and available versions are displayed. Tick the check box under Name if it is not already ticked then click on Upgrade.
9. Enter the password of the existing configuration (not the default). Click OK and IP Office will reboot and undergo the upgrade cycle. This takes around a minute to complete. Click OK to finish once the upgrade has completed. This will close the UpgradeWiz window.
